Accident Investigation Final Report

All Engines-out Landing Due to Fuel Exhaustion

**Air Transat
Airbus A330-243 marks C-GITS
Lajes, Azores, Portugal
24 August 2001**

22 / ACCID / GPIAA / 2001

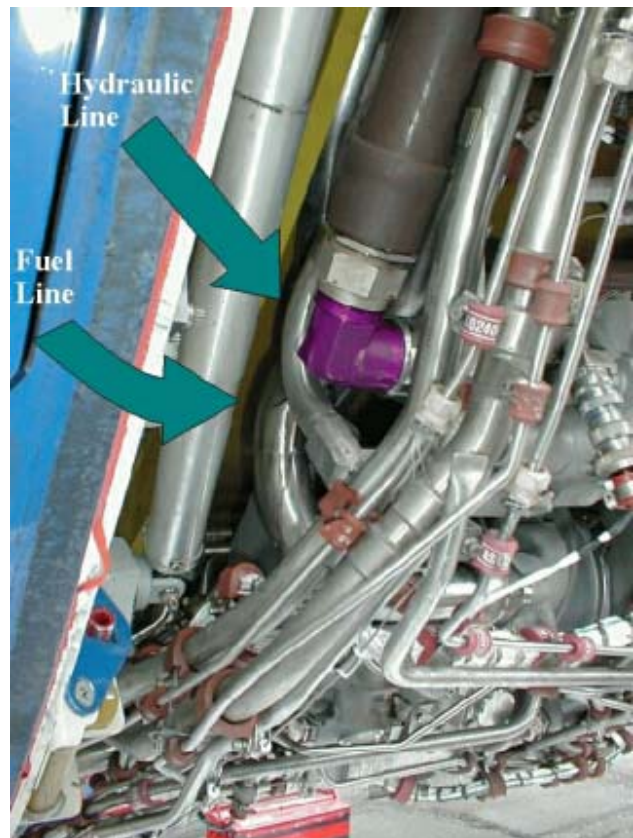
Figure 3 - Right Engine Pipe Contact

Both reports concluded that the fuel and hydraulic tubes fully matched the drawing characteristics for material, form and shape. The fuel tube wall section was measured and showed that the wear had reduced the wall thickness by 0.005 inches, and that the hard contact had resulted in a dent measuring 0.044 inches deep. The examination concluded that the fuel tube fractured in high cycle fatigue at multiple initiation sites in the bore and the outside diameter, due to a combination of vibratory stresses being superimposed on the tube deformation. Also noted were some scratches and deep scores around the chafed location on both tubes. Report MFR 41281 stated that these marks are believed to have been made at the time of installation of the engine because this was the only time the post-SB fuel line and pre-SB hydraulic lines were mounted adjacent to one another. The report con-

cluded that the scratches and scores were directionally aligned and that they could have been caused from repeated contact from a blunt instrument, such as a screwdriver being inserted between the tubes in order to force a clearance between them. There were no cracks initiated from the score or scratch marks.

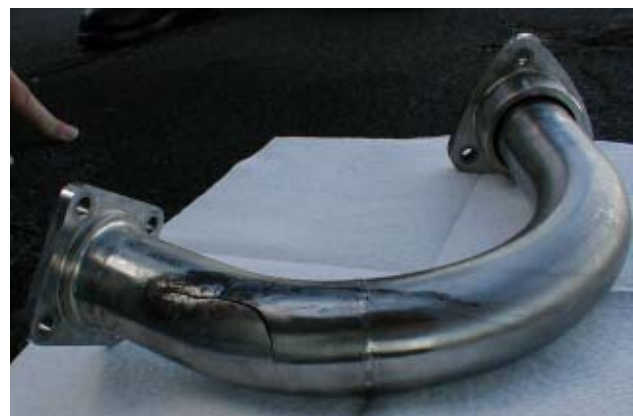
Figure 4 Fuel Pipe Crack & Scratches

The initial inspection of the right engine following the occurrence uncovered the presence of an L-shaped crack on the inlet fuel tube wall (Part No FK30383). The crack was approximately 3.0 inches (80mm) long, and was spread to a width of about 1/8 inches (2.5mm). In addition, the hydraulic outlet tube (pressure) for the rear hydraulic pump was found to be in hard contact with the fuel tube. The cracking on the fuel tube extended to both sides of a mechanically worn (chafed) area where the tubes came into contact. It was evident that the interference and chafing occurred due to the mismatched installation of the post-mod fuel tube (P/N: FK30383) and pre-mod hydraulic tube (P/N: LJ51006). Based on the DFDR data, it was determined that the fuel leak rate through this cracked reached a maximum of about 13.0 metric tons per hour.
